**RAIL ALIGNMENT FOR GEOLOGIC REPOSITORY AT  
YUCCA MOUNTAIN, NEVADA PROJECT**

**Final Draft  
WETLAND TECHNICAL MEMORANDUM:  
Functional Assessment, Impacts and Conceptual Mitigation**

**March 2008**

*Prepared by:*  
URS Corporation, Portland, Oregon

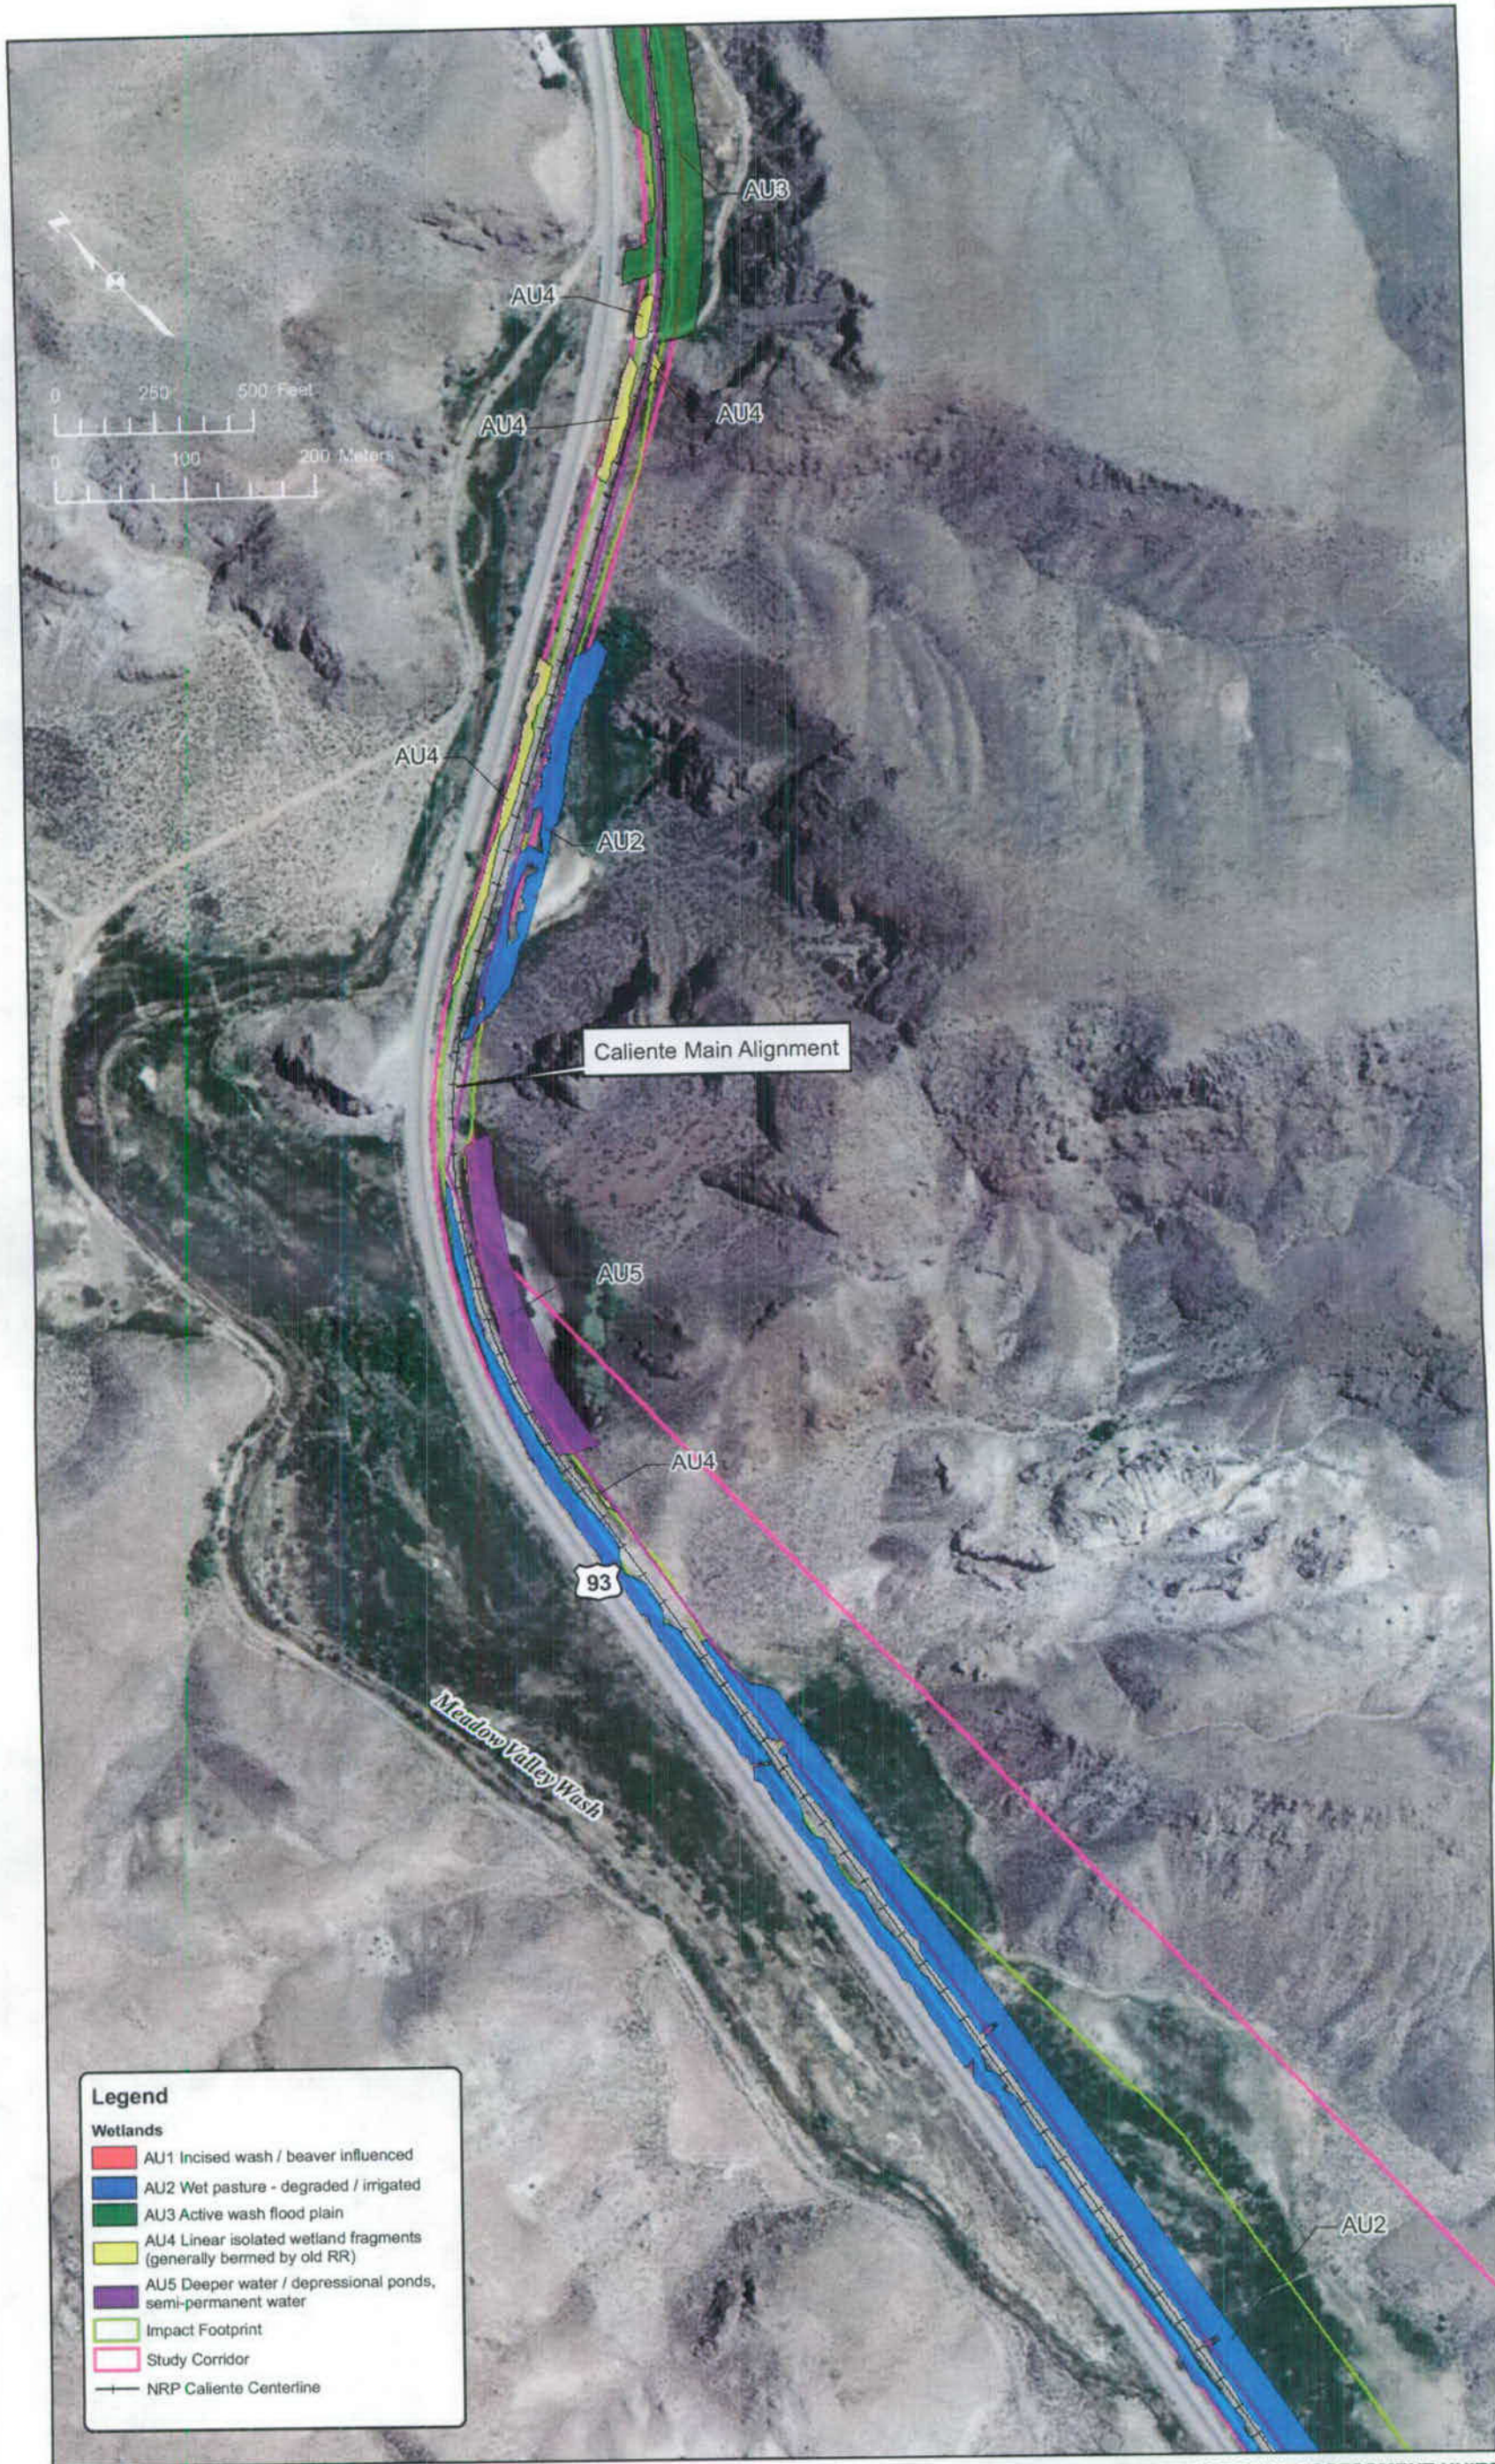
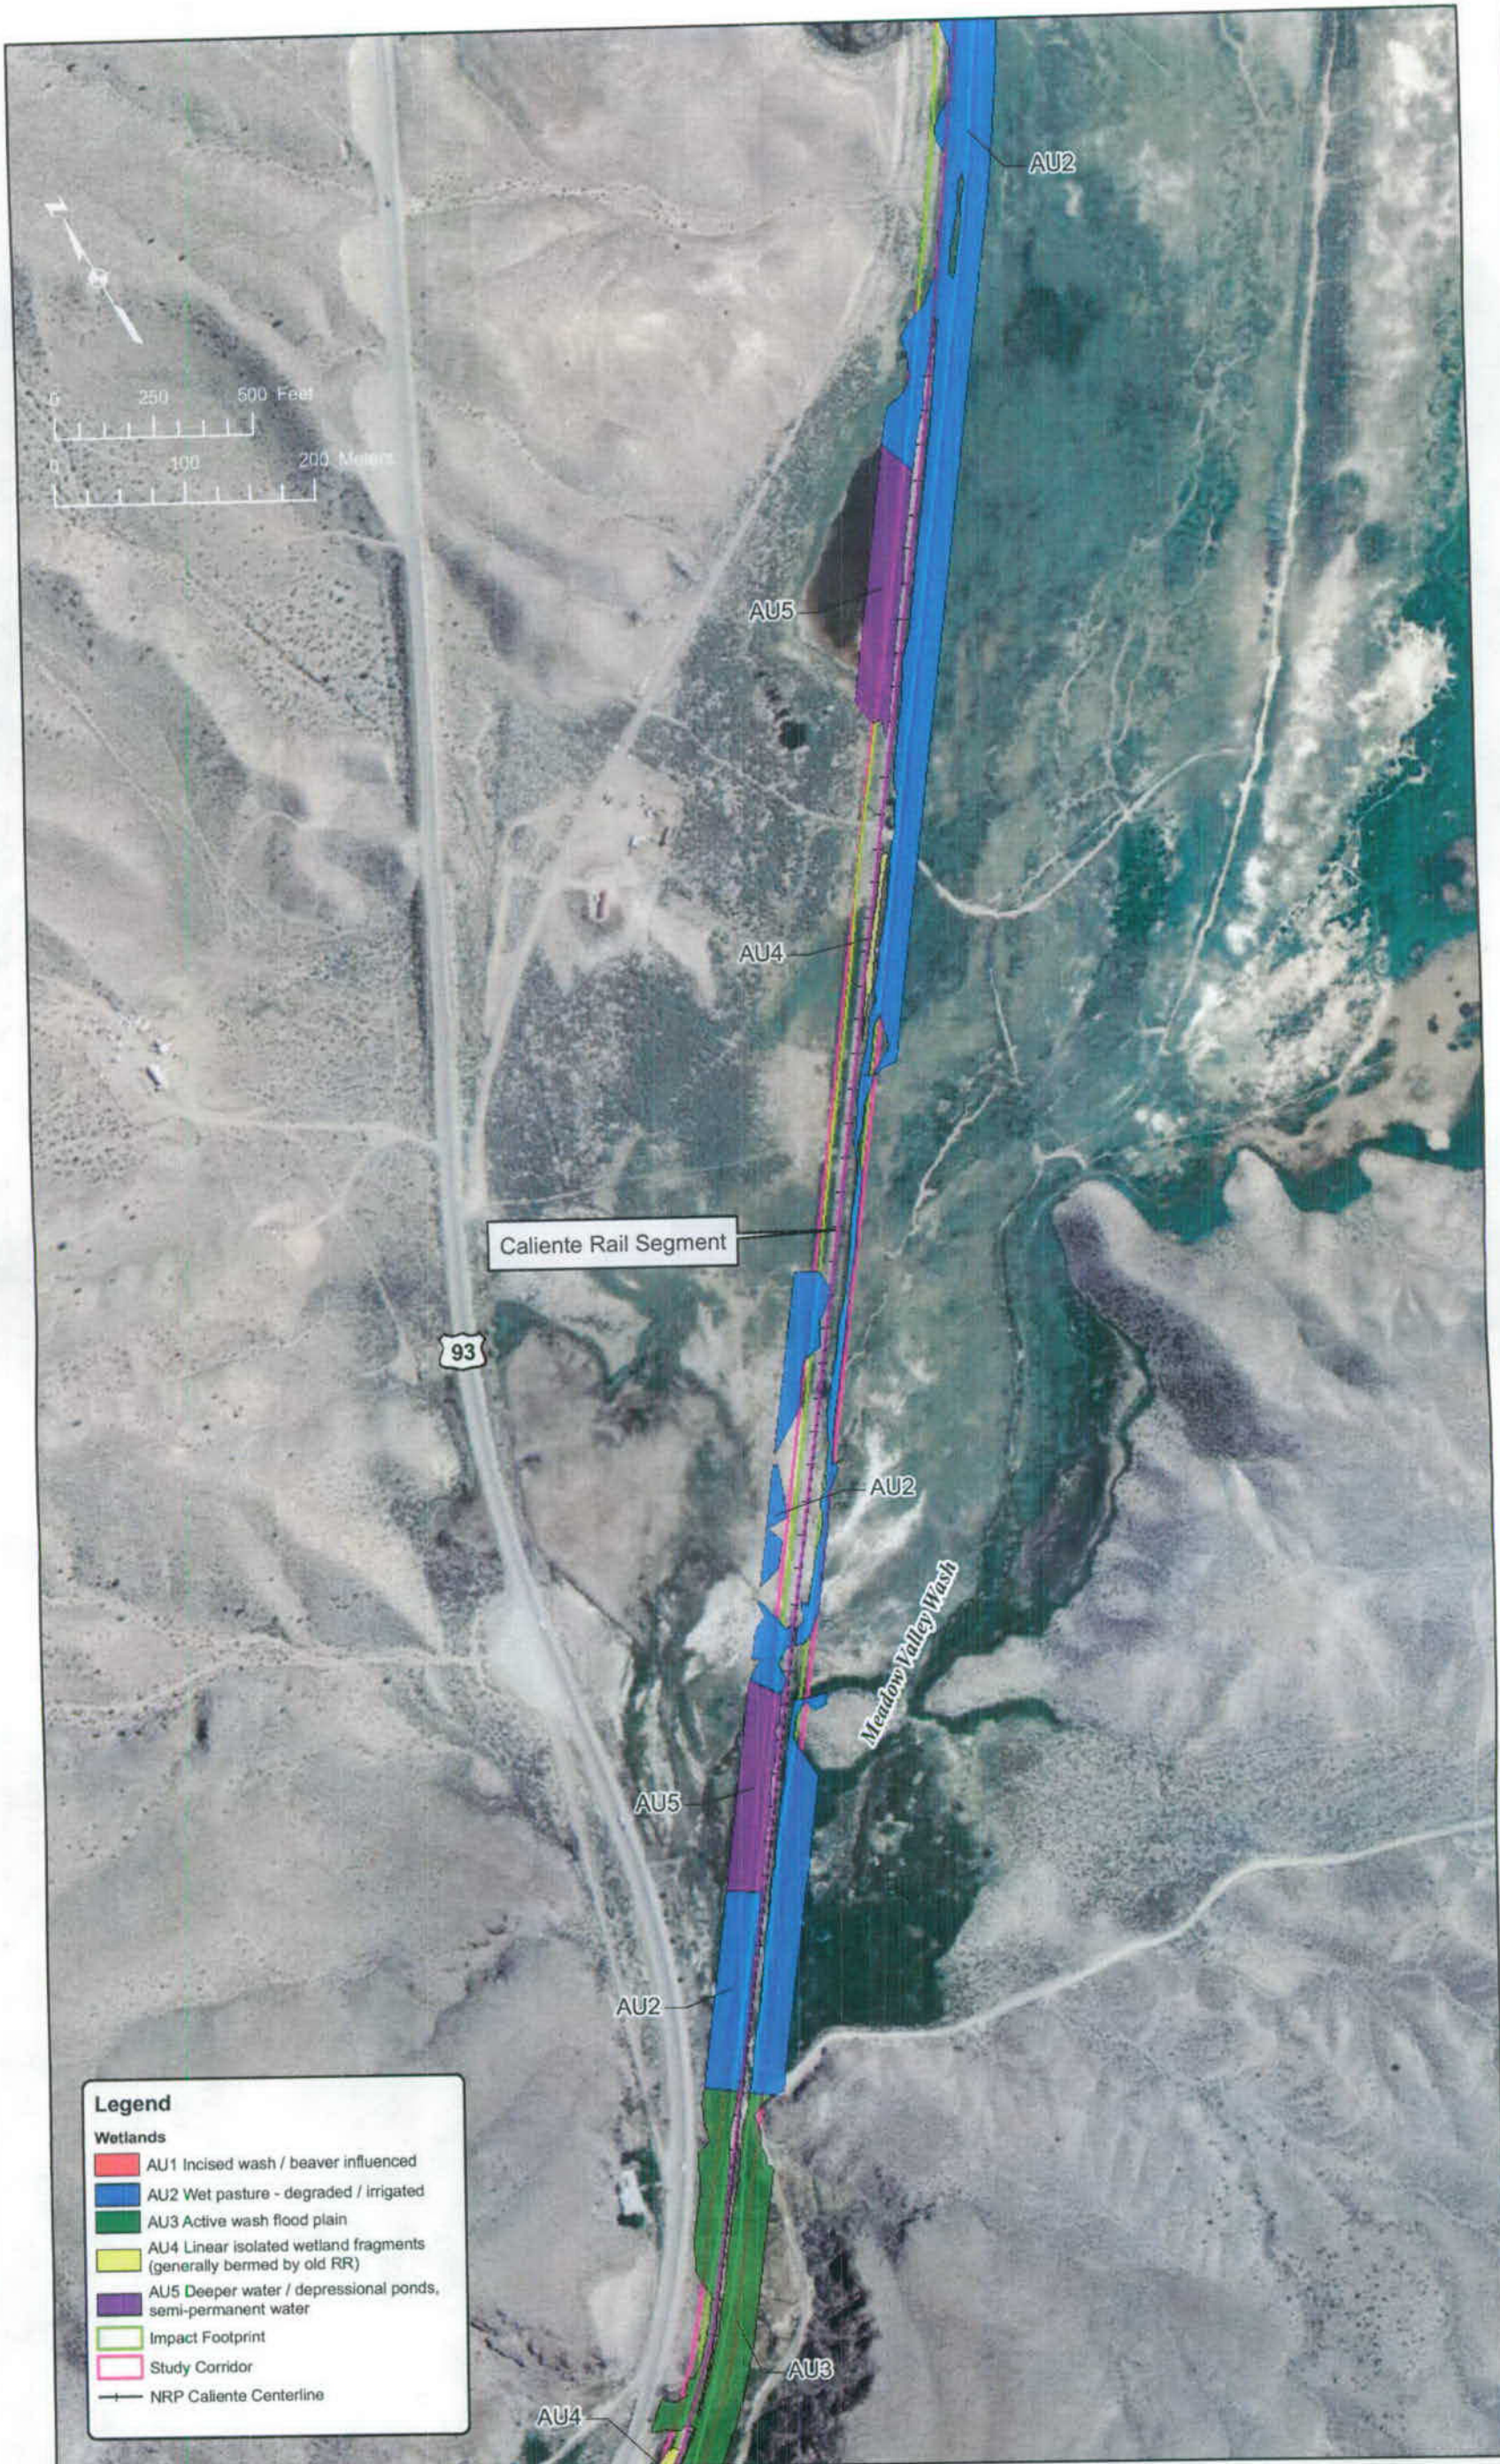
**FIGURE 3c**

Assessment Unit 5 includes wetlands associated with deeper water, basin topography (e.g., pond to the north of Indian Cove Staging Yard Option). This AU is found in Figures 3c and 3d. These wetlands classify as Depressional under the HGM framework. Wetlands in this AU in the study area may have formed or been influenced toward deeper-water wetlands as a result of probable human activities such as excavation/borrow (e.g., CC12, PBS&J 2006, Figure 4H) and construction of berms (e.g., old railroad bed) that serve to interrupt downslope water movement.

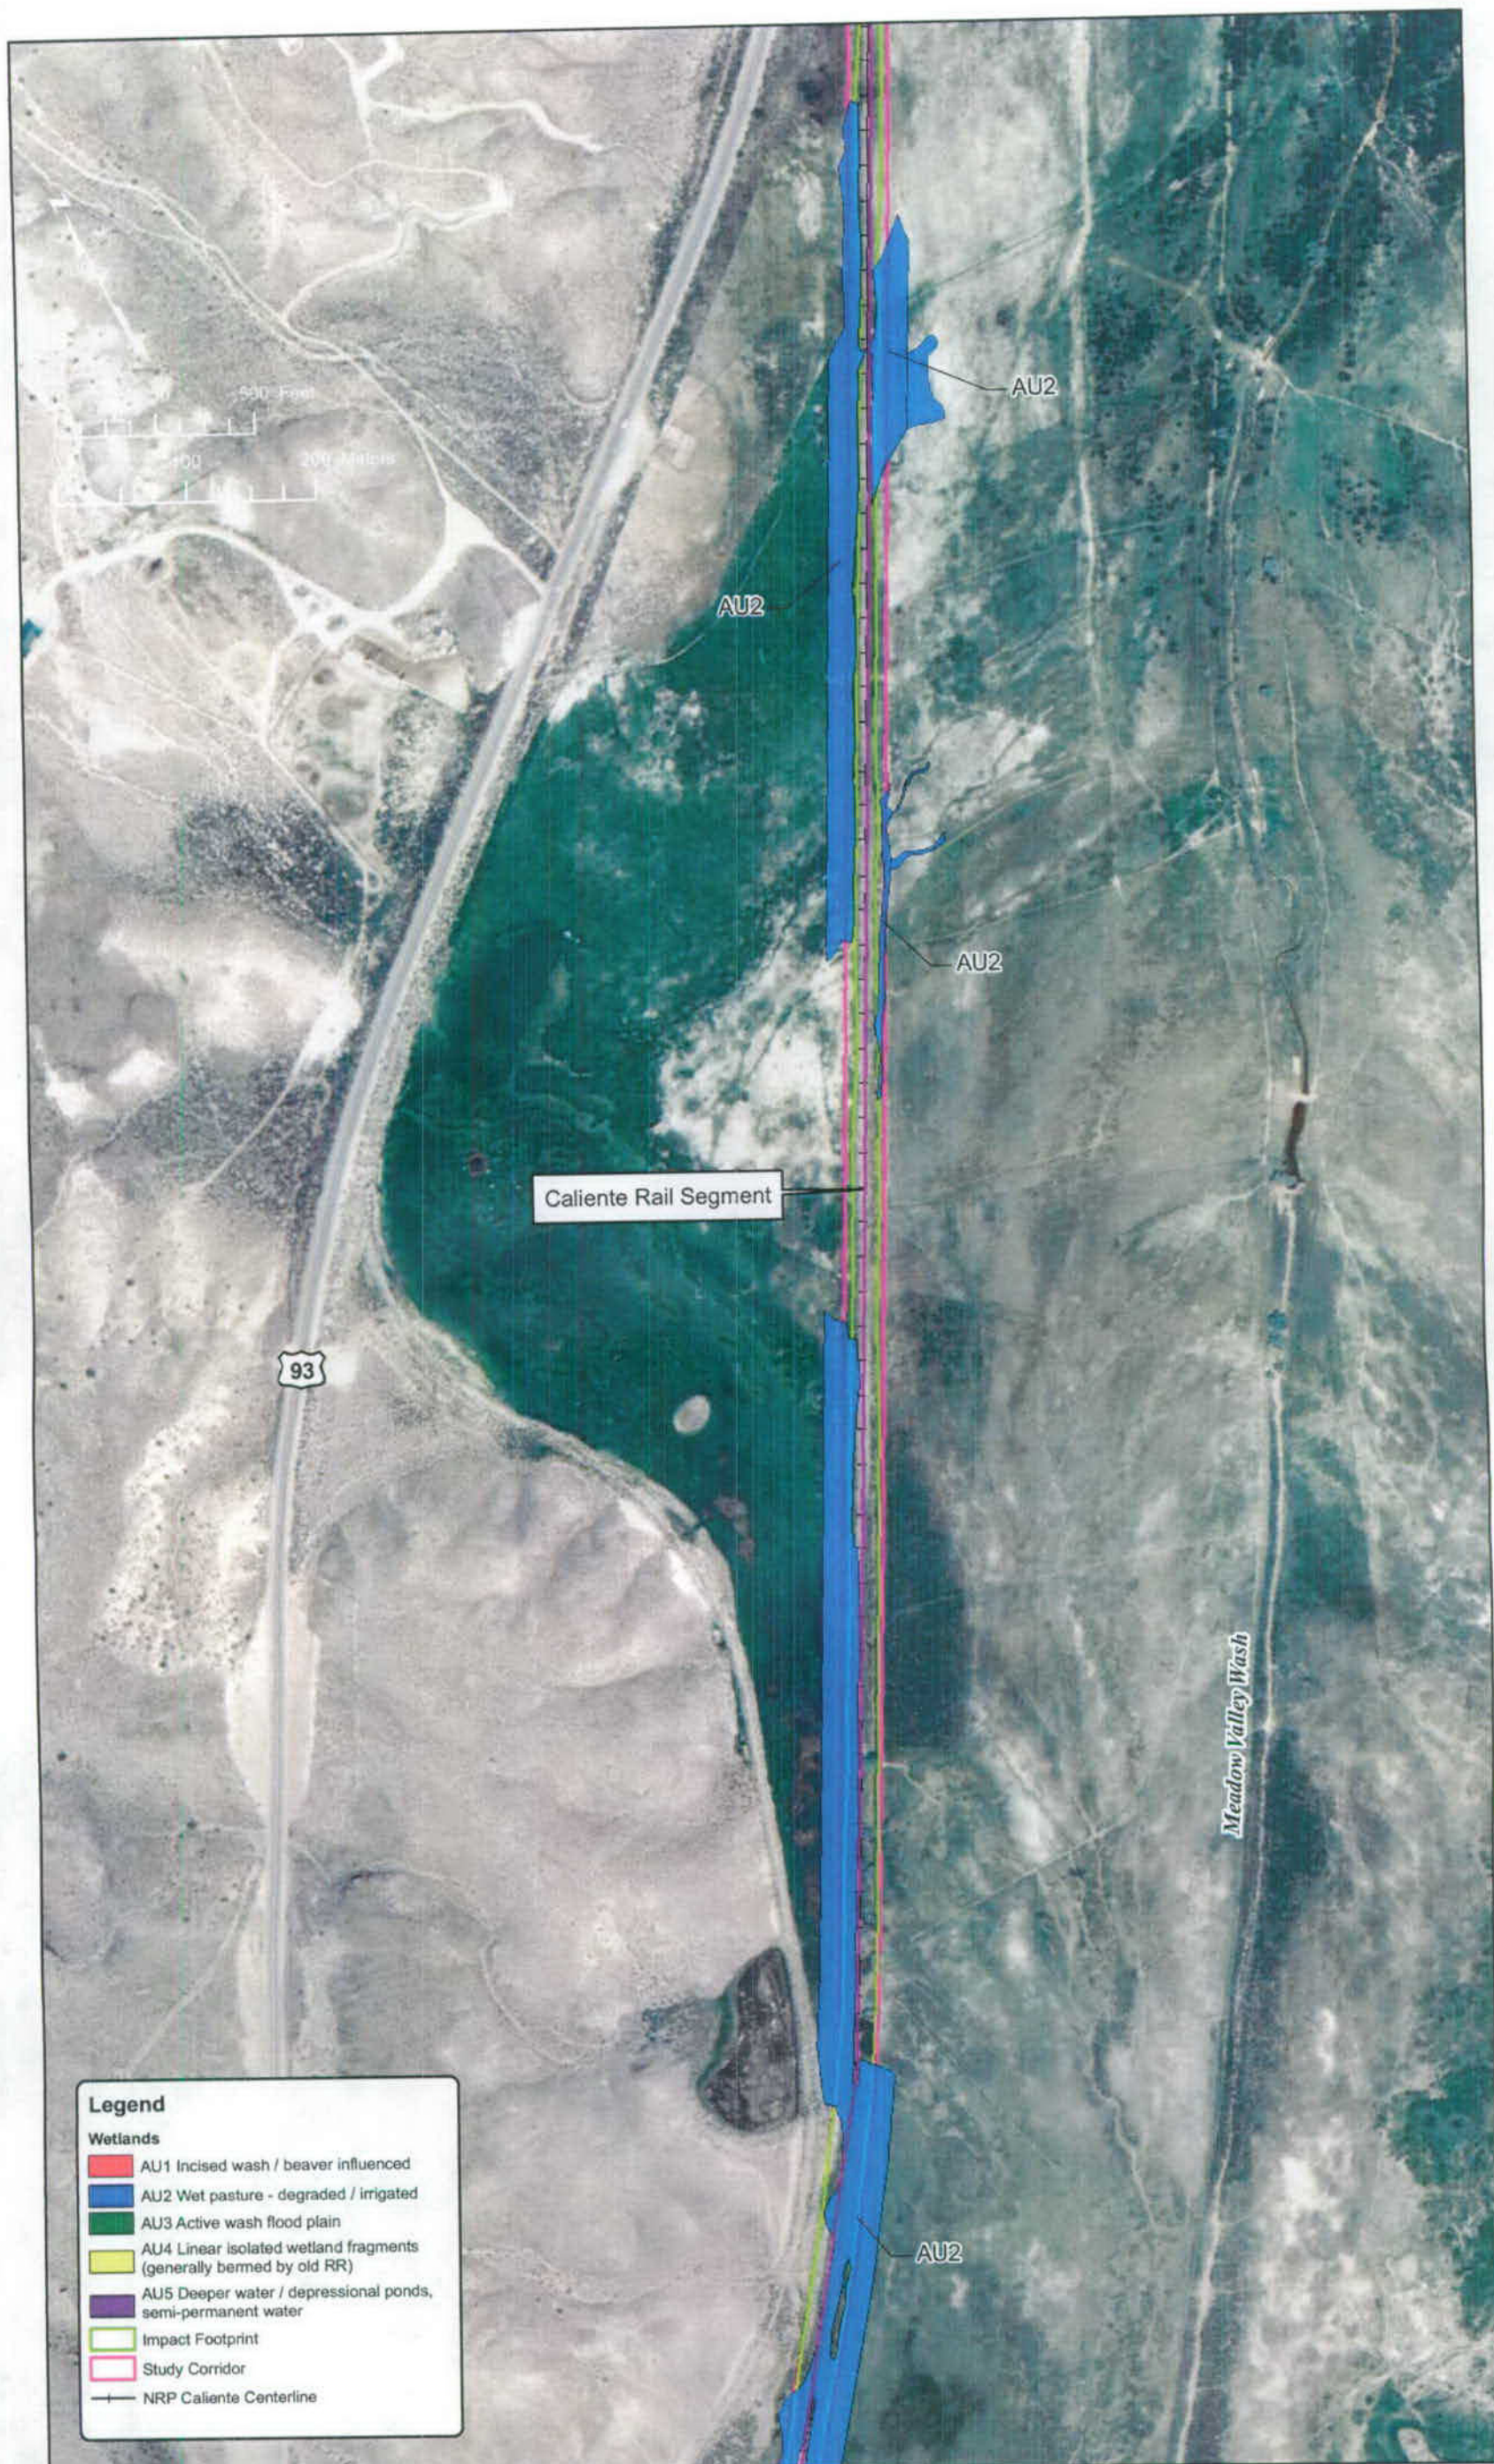
FIGURE 3d

# CALIENTE RAIL SEGMENT FUNCTIONAL ASSESSMENT UNITS

Quantification of direct wetland impacts associated with the Caliente alternative segment, based on current project design assumptions<sup>1</sup>, results in an estimate of 7.11 acres (of which 6.94 acres are assumed jurisdictional) (Figures 2, and 3a – 3j and Table 1). The largest extent of direct impacts would be associated with two regions within the first five miles of the alignment: Indian Cove and southern Meadow Valley. These areas primarily support wetland pasture grazed year-round by cattle, and are irrigated with water diverted from Meadow Valley Wash, in addition to hydrological input by springs and other

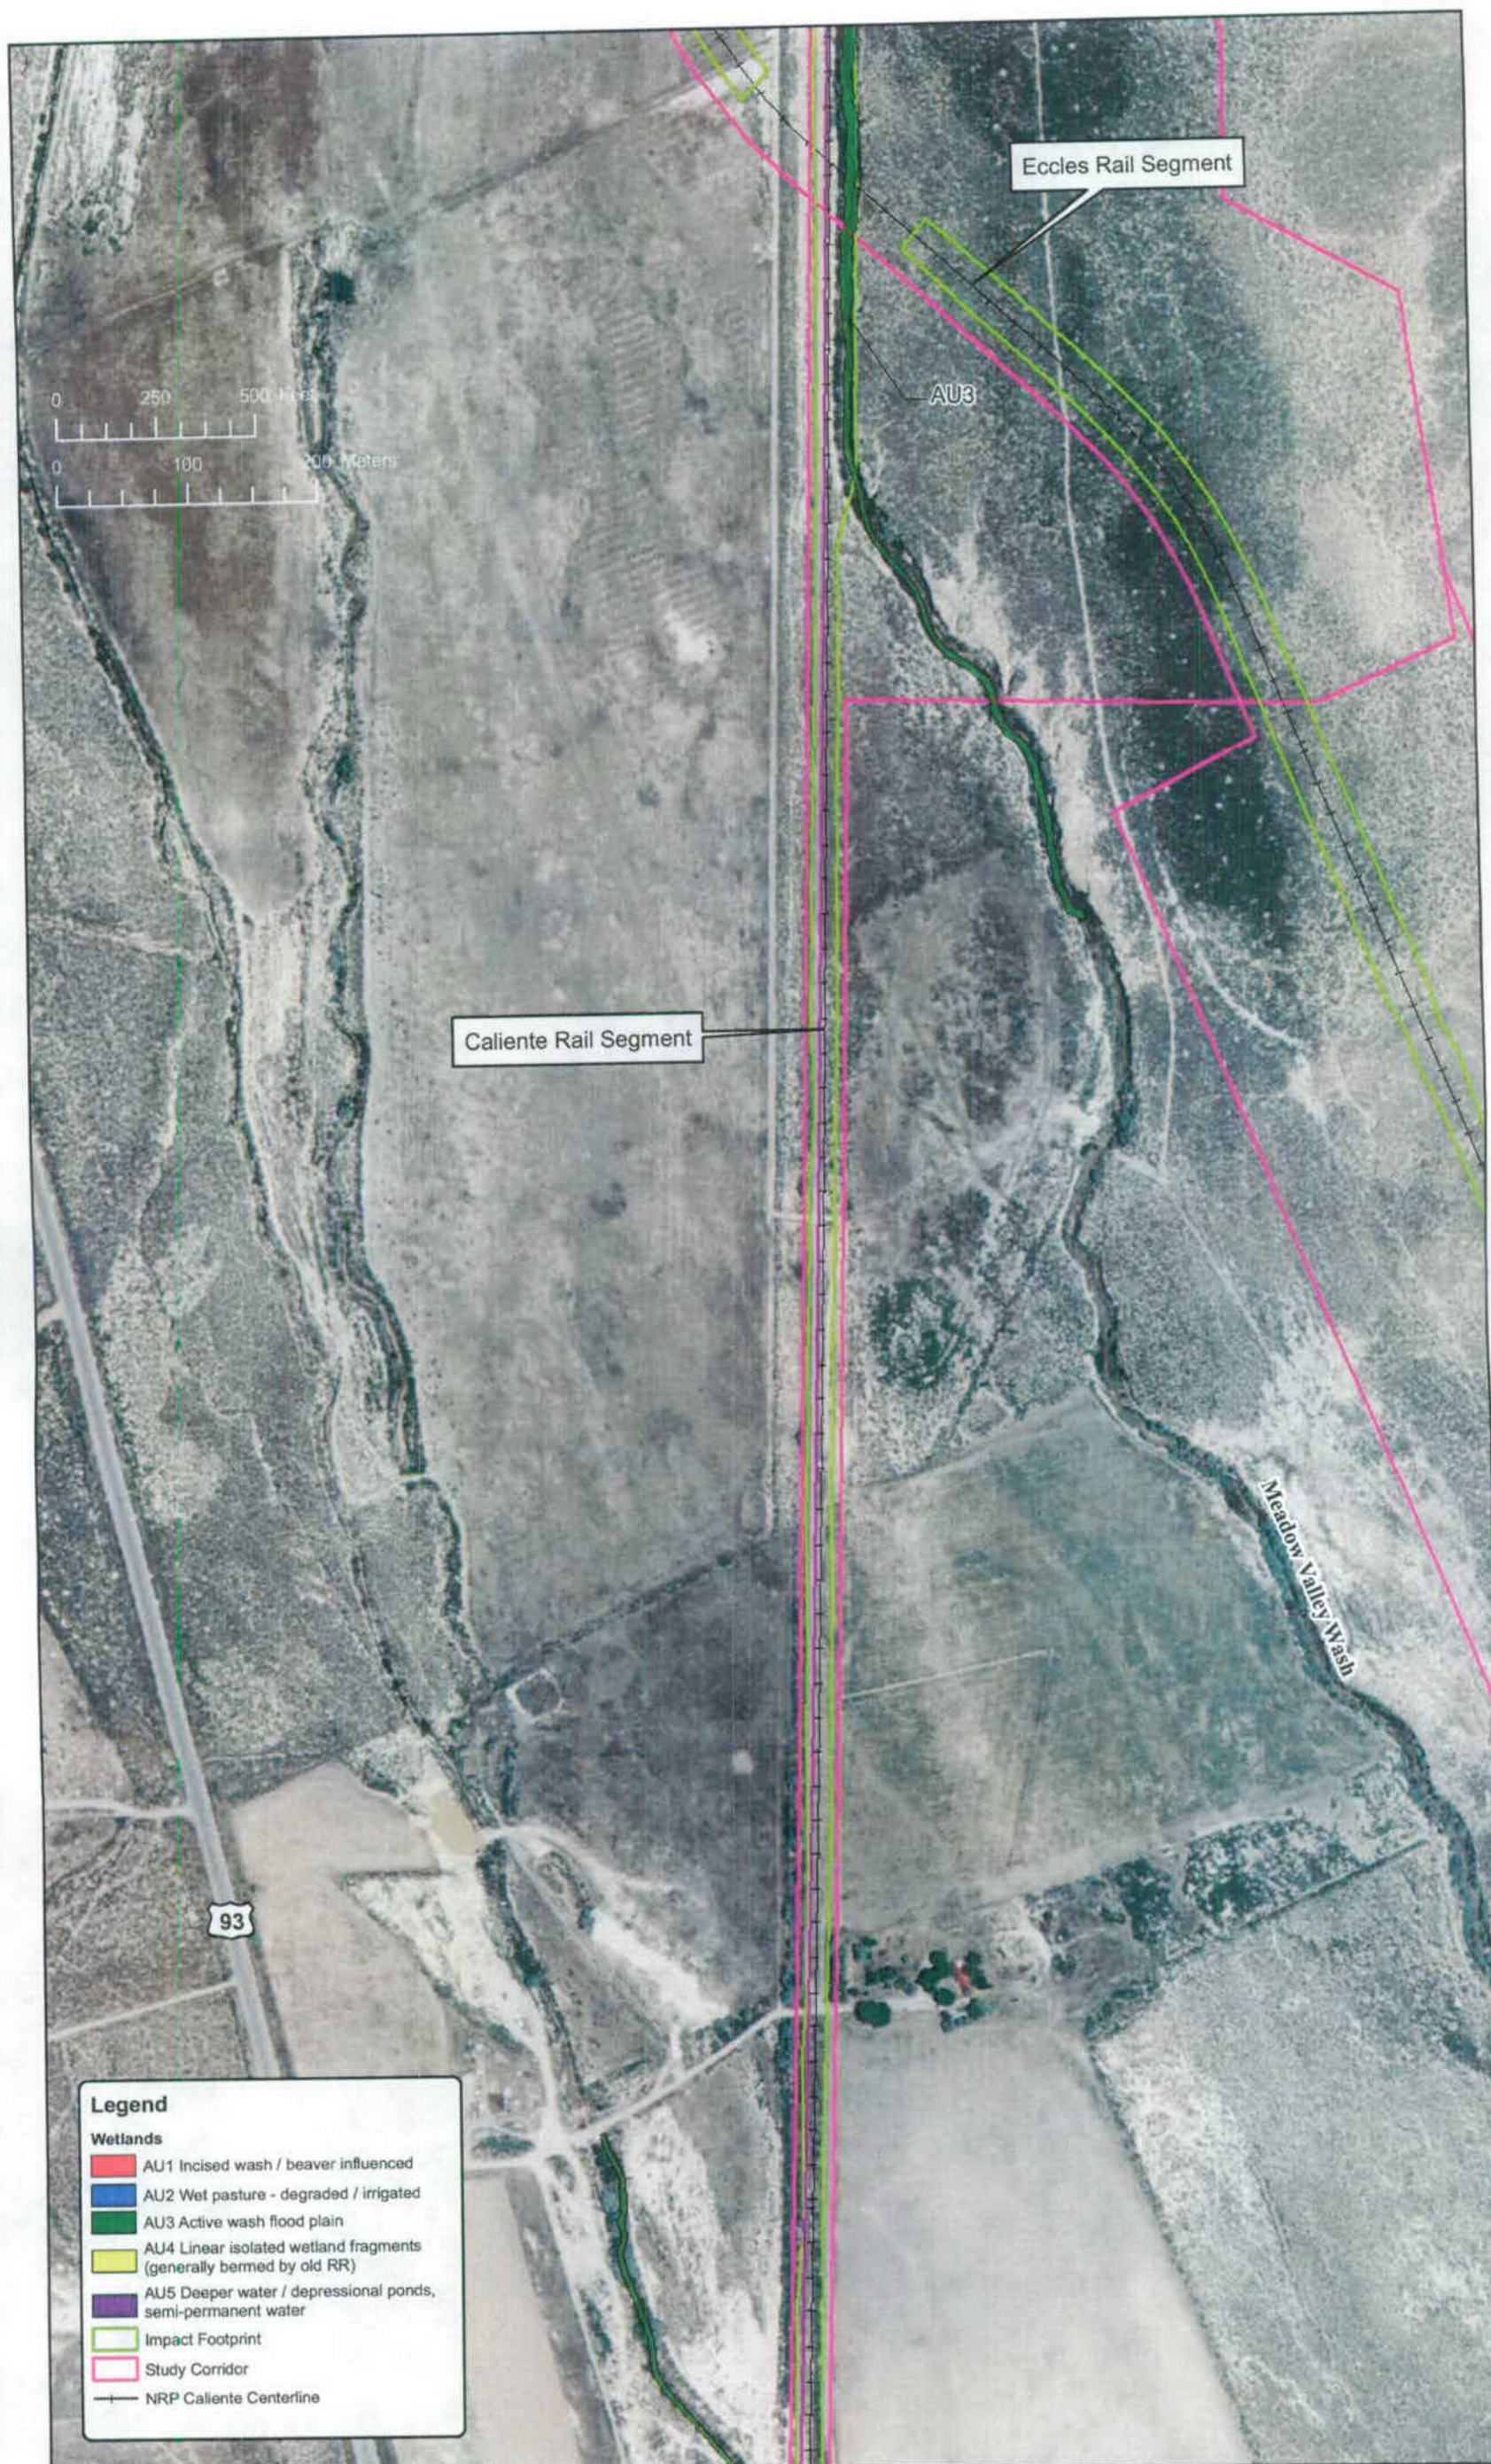
FIGURE 3h

# CALIENTE RAIL SEGMENT FUNCTIONAL ASSESSMENT UNITS

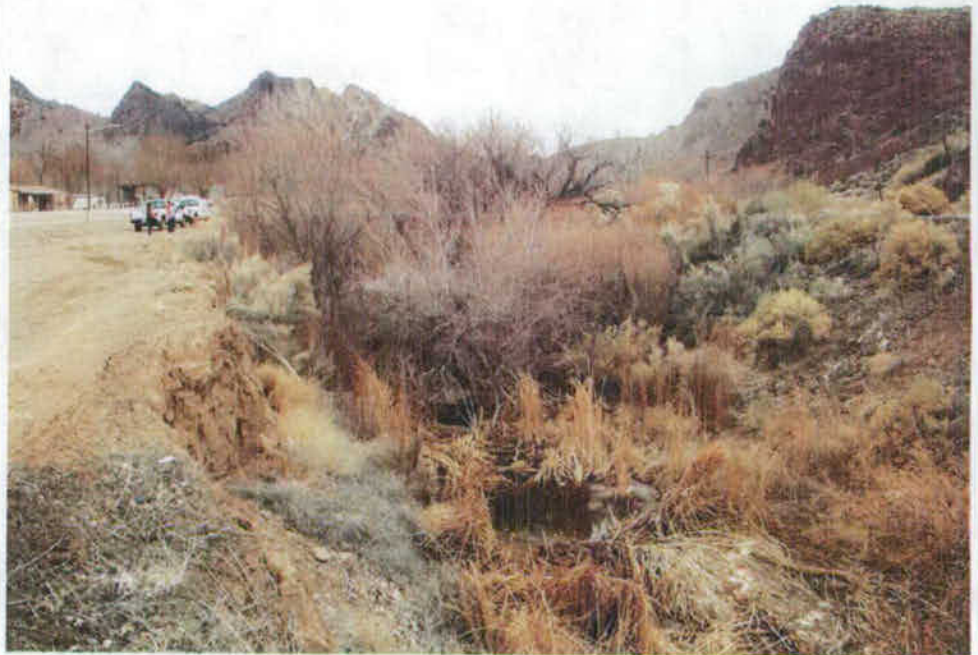
Photo No.

Depicts central portion of CC7,  
and is typical of Wetland  
Function Assessment Unit AU-2.  
Grazed pasture with ponding  
likely from groundwater/rainfall  
in this season, not irrigation.  
Pasture is relatively flat with  
microtopography and low man-  
made "check-berms" that run  
east-west in two or three places  
along the north-south axis of this  
wetland pasture.

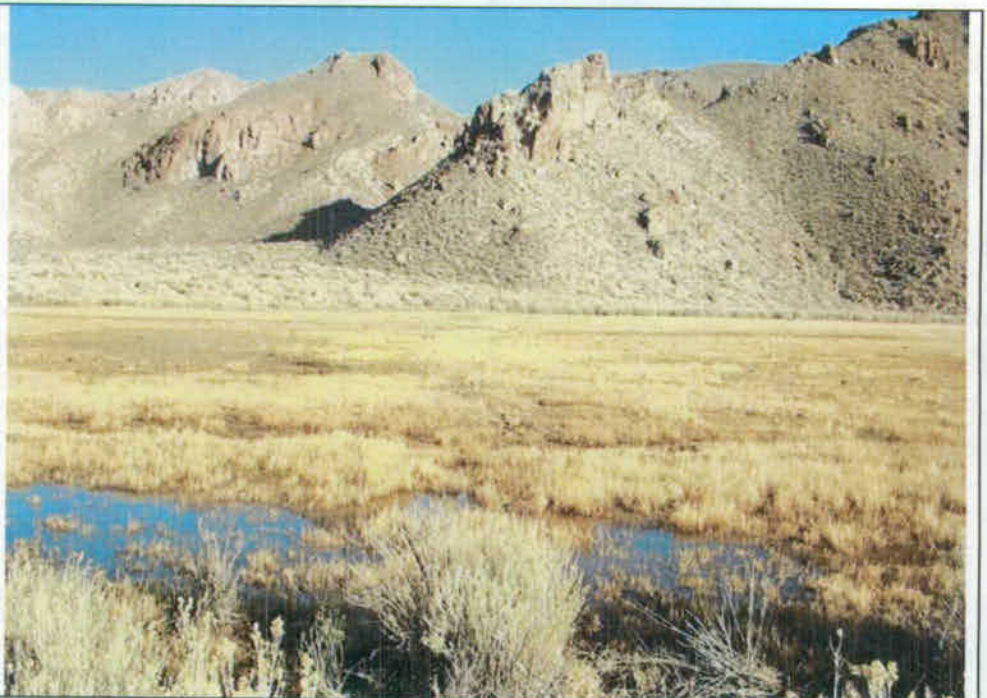
<b>Photo No.</b> <b>3</b>	<b>Date:</b> February 12, 2008

<b>Direction Photo Taken:</b>  North (upstream) along Meadow Valley Wash in Meadow Valley Pasture.		
<b>Description:</b>  Depicts northeast portion of CC17 with typical Wetland Function Assessment Unit AU-3. Shows floodplain with Riverine Flow-through wetland, fringing bulrush and landscape connectivity between channel and adjacent wetland meadow that typifies AU-3.

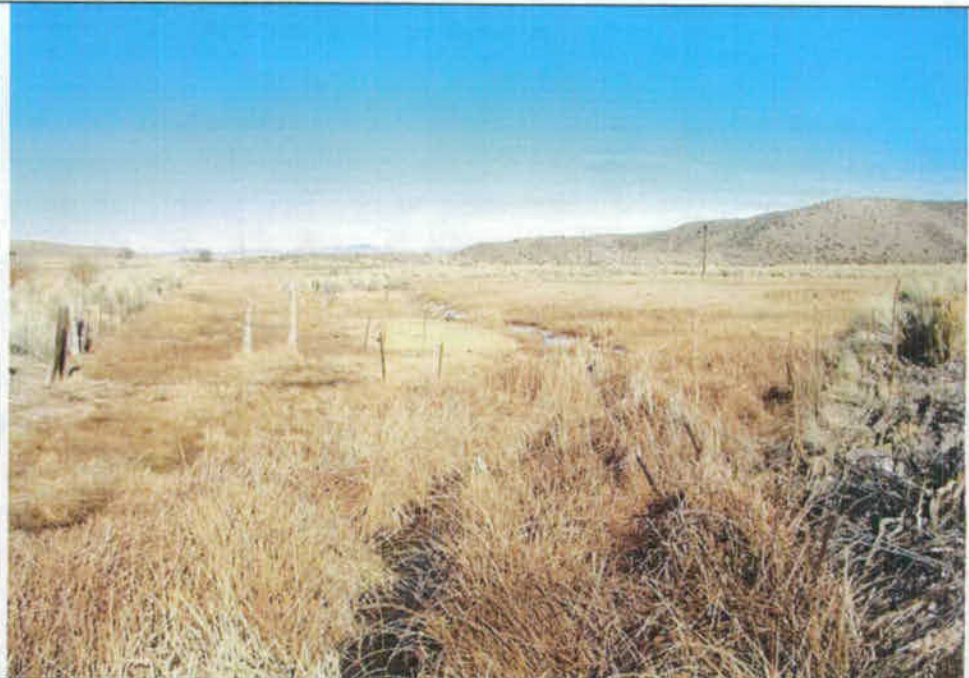
<b>Photo No.</b> <b>4</b>	<b>Date:</b> February 12, 2008
<b>Direction Photo Taken:</b>  North from midway along the east border of CC-9, separated by old railroad berm (photo origin point) from Indian Cove Pasture to the East/right side.	
<b>Description:</b>  Depicts northern portion of CC9, typical of Wetland Function Assessment Unit AU-4. Shows narrow, linear character of AU-4 wetlands, which are typically west of the old railroad berm. This wetland has a narrow, shallow ditch meandering through. Most AU-4 wetlands do not have this feature and appear as narrow strips of grazed wetland pasture.

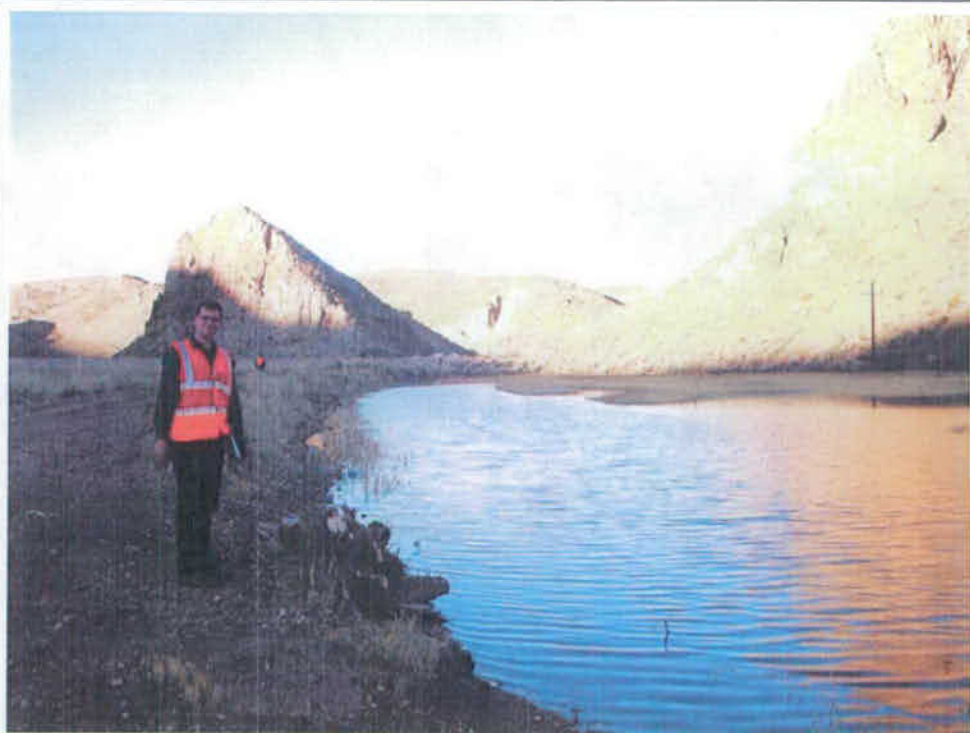
<b>Photo No.</b> <b>6</b>	<b>Date:</b> February 13, 2008
------------------------------	-----------------------------------

Depicts western portion of CC12, typical of Wetland Function Assessment Unit AU-5. A mixture of shallow open water and vegetation, in this case pasture/meadow, low growing grasses, characterizes AU-5 wetlands. This wetland appears likely to have been historically excavated in the western portion this was observed to be ponded during the field investigation.

The AU-5 wetlands are generally perennial in character, but occasionally dry out. As such the hydrologic regime is semi-permanent in nature. Patches of open water and vegetation may occur in characteristic “duck pond” fashion. With typically 1.5-3 feet of water depth, cattle have little impact except around the edges, which except for in the case of wetland CC12 consist of wetland pasture. As such, these wetlands typically support a less degraded vegetation community, and are characterized by wetter-tolerant vegetation. Hardstem bulrush is dominant in these wetlands, and wetland pasture species (similar to AU-2) occurs in drier areas.

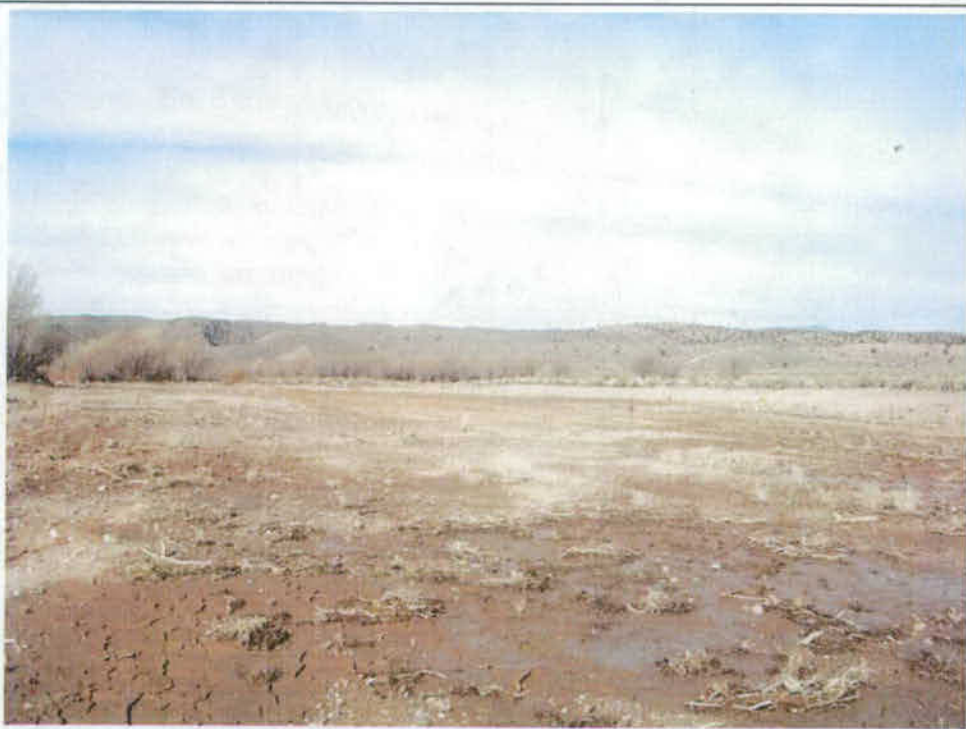
Depicts WT-9 in the Eccles Alternative Segment, typical of Wetland Function Assessment Unit AU-6. This wetland AU lies within the active floodplain of Clover Creek. Tamarisk seedlings ranging from shin- to waist-high are visible against the mostly bare substrate. Deposition of sediment and small woody debris were observed indicating active stream flow through this area.
